Pall Corporation

Pall's Coreless Filter Solves Fouling of Cold Box Downstream of Molecular Sieve Driers

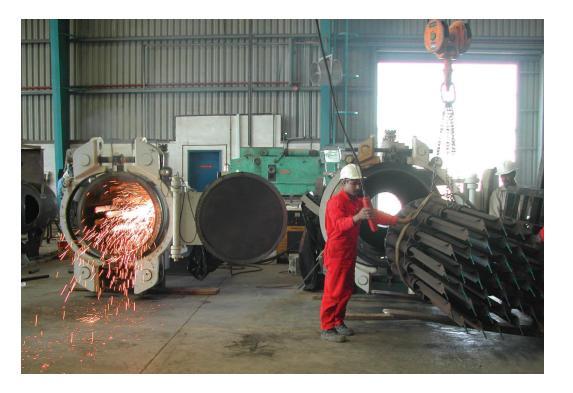
Cut out and removal of existing internals

The new tubesheets, the inner cores, and the stand-pipes were fabricated and assembled by Pall, then internals were delivered to a local subcontractor close to the plant. During the shutdown of the plant, the six existing filter vessels were disconnected and delivered to the subcontractor, where the existing internals were removed and the new internals were welded. The modification of the six filter vessels was made within two weeks, so that it had no impact on the production schedule of the plant.

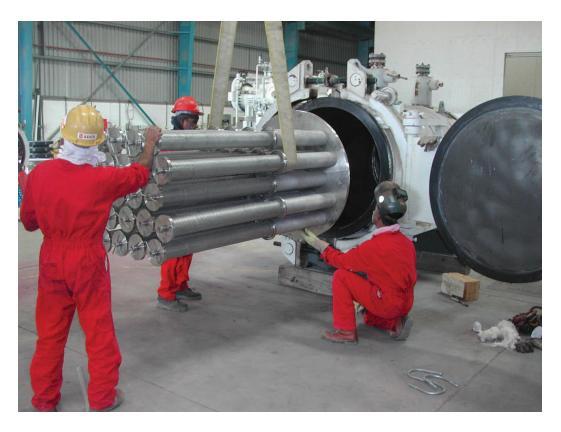
Installation of Pall's internals within the same vessel

Pall proposed new filter plates (tubesheets) to be fitted with 19 and 22 cartridges depending on the size of the existing vessels. Pall's Coreless filters were recommended as a replacement of the existing 1 micron cartridges.
