## Application

## Bulk Diesel Fuel

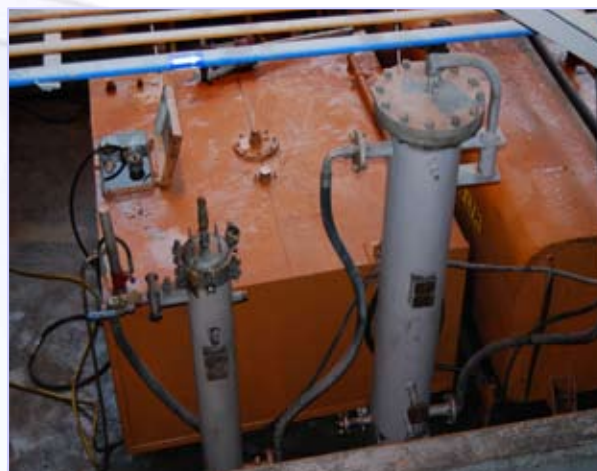
**Pall High Flow Ultipleat<sup>®</sup> & PhaseSep<sup>®</sup> filter housings installed at one of the bulk fuel tanks**

The mine installed numerous Pall **HighFlow Ultipleat**<sup>®</sup> filters to remove particulates and Pall **PhaseSep**<sup>®</sup> coalescers for water removal on strategic bulk fuel tank locations on site.

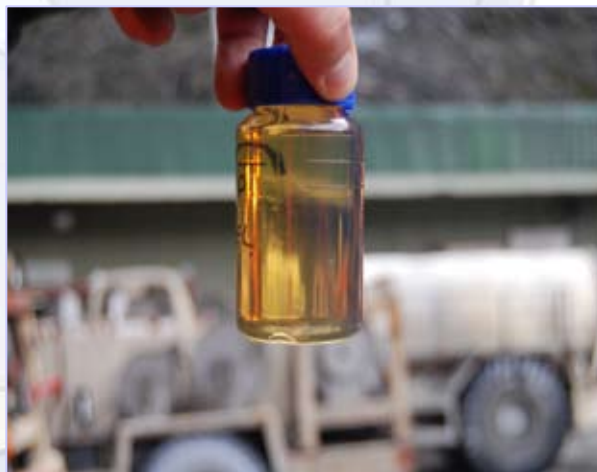
**Diesel fuel sample downstream of Pall fuel filters; ISO Cleanliness Code -13/10 and water content below 100ppm**
