Application

Detecting SAG Mill Seal Failures

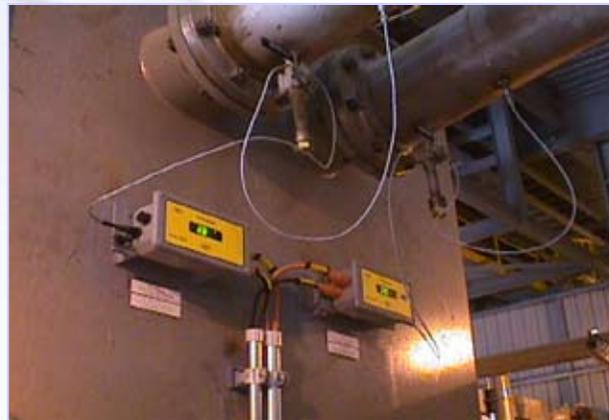
Pall WS03 Water Sensors installed on SAG Mill Lube Oil Return Lines

The mine installed 2 x Pall WS03 Water Sensors into the main lube oil return lines prior to the main lube tank. Each monitor was connected via the WS03's in-built 4-20mA signals to the mine's DCS System to alert operators in real time of seal failures.

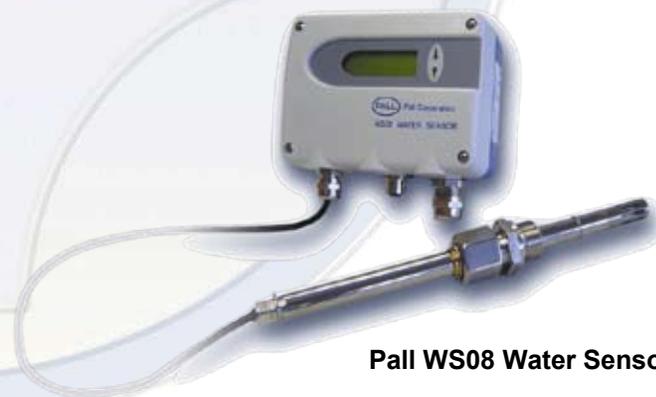
Pall WS08 Water Sensor

*** New installations should utilize Pall's latest generation WS08 Water Sensor as pictured below.**
