## Application

## Blast Hole Drill Rig Hydraulics

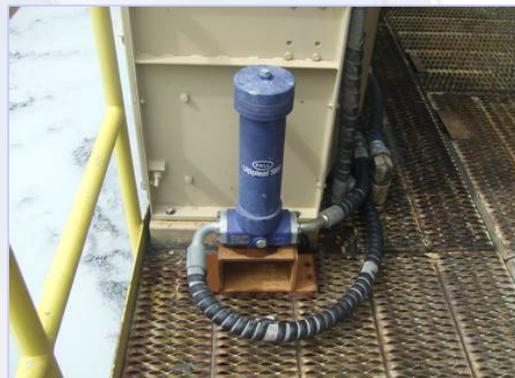
Pall Ultipleat USRT UP319 Filter

The mine installed a Pall UP319++13ZB9 **Ultipleat**<sup>®</sup> **USRT** filter housing complete with a UE319AZ13Z filter element and an RC861CZ091ZYM electrical indicator to provide the operator with remote indication of the filter element blockage.

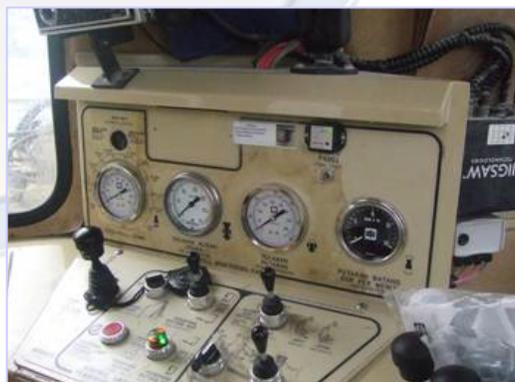
In cab filter element blockage display
