Application Bulletin

Mobile Equipment OEM

Hydraulic Rock Breaker attachment – 14 to 38 tonne capacity used in cement, granite, iron ore and general mining and construction applications

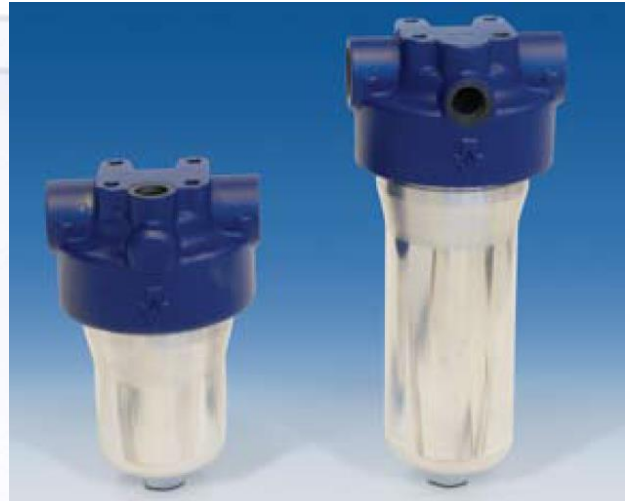
Pall **Versalon F410 Series Filter**

Pall recommended a **Versalon™** F410 series return-line filter rated at 12 micron ($\beta_{12(c)} > 1000$) between the breaker attachment and the system reservoir, and field trials in different terrain / site conditions. Oil analysis was performed every 250 hours up to 1000 hours service.
